# Argumentation BIANCA butterfly valve with ULTRAFLO<sup>®</sup> liner

## Extremely low permeability for a longer operating life and improved safety

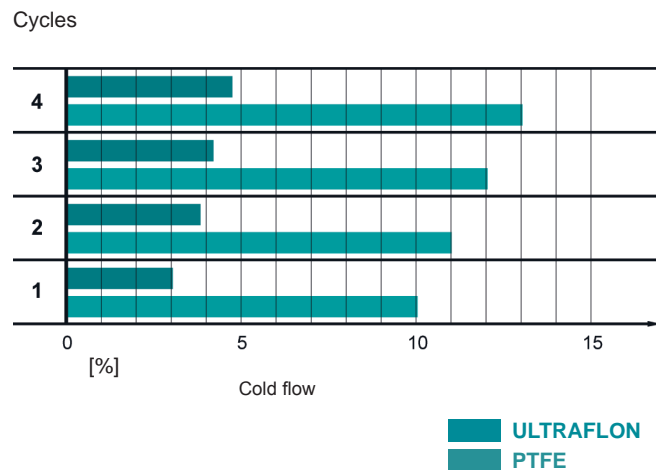
### Deformation

under repeated load „Cold flow behavior“

Loading : 15 N/mm<sup>2</sup>, 4 cycles  
Duration : 100 hours each cycle  
Temperature : 23°C (73°F)  
Perm. deformation after 24 hours recovery

The much denser polymeric microstructure of the new **ULTRAFLO<sup>®</sup>** liner, which is optionally available with the **BIANCA butterfly valve**, exhibits a significantly lower tendency to undergo cold flow. The problems associated with cold flow are thus effectively prevented, guaranteeing trouble-free valve function over a longer operating life. The improved stability of the **ULTRAFLO<sup>®</sup>** liner makes it the liner of choice for vacuum applications. The operator benefits from improved operational safety when handling aggressive and ultrapure media.

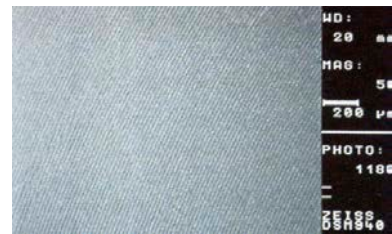
50x enlargement of the surface of a machined ULTRAFLO<sup>®</sup> liner

After machining, the surface of the **ULTRAFLO<sup>®</sup>** liner is much smoother than that of a liner made of PTFE making the **ULTRAFLO<sup>®</sup>** component less susceptible to abrasive wear.

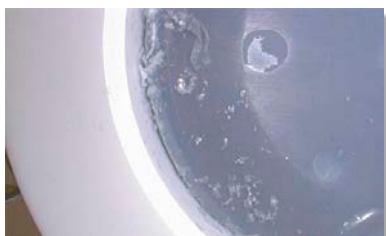
Abrasion of a standard PTFE liner

With its **ULTRAFLO<sup>®</sup>** lining collar, precision machined to extremely high tolerances, the **Bianca** butterfly valve has been shown to have the lowest degree of material abrasion between the liner and the disc. Endurance tests have demonstrated that the quantity of abraded particles released into the medium is significantly reduced with **ULTRAFLO<sup>®</sup>** liners. The significantly reduced wear means a longer operating life for the valve, thus ensuring increased safety and a corresponding fall in maintenance costs.
